A STUDY OF DEGRADATION OF PLATES FOR  
NICKEL-CADMIUM SPACECRAFT CELLS

Interim Report

TRW Report No. 24118-6001-RU-00

November 1973

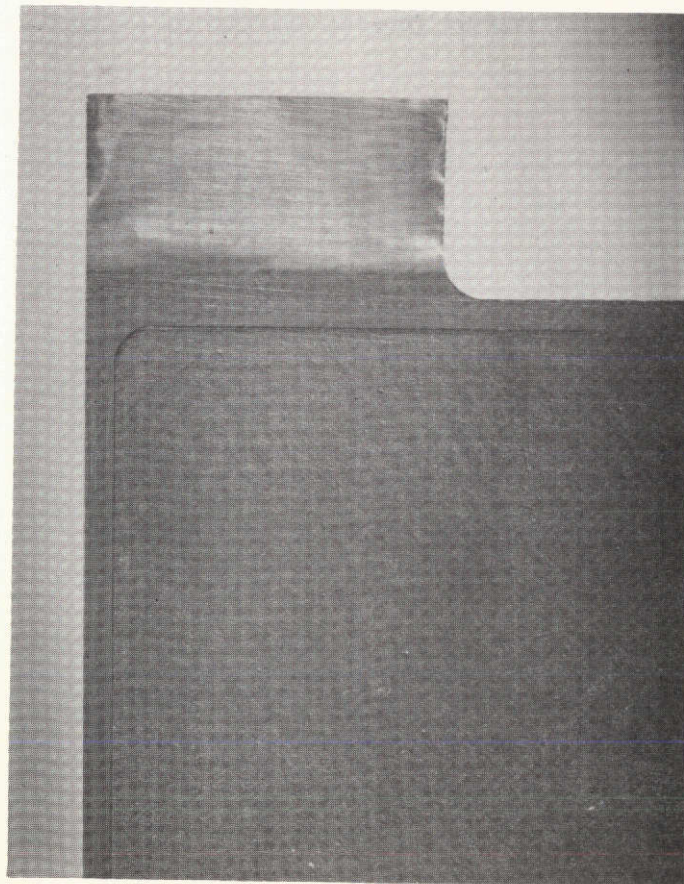
Figure 29. Plate Tab Area, Showing Wide Coining and Trim to Remove All Taper at the Top Cut Edge (TRW Photo No. 104798-73)
